DEPARTMENT OF TRANSPORTATION

Contract #: 04-0120F4Cty: SF/ALA Rte: 80 PM: 13.2/13.9File #: 69.28**WELDING INSPECTION REPORT****Resident Engineer:**Siegenthaler, Peter**Address:** 333 Burma Road**City:** Oakland, CA 94607**Report No:** WIR-021825**Date Inspected:** 15-Mar-2011**Project Name:** SAS Superstructure**OSM Arrival Time:** 700**Prime Contractor:** American Bridge/Fluor Enterprises, a JV**OSM Departure Time:** 1900**Contractor:** Zhenhua Port Machinery Company, Ltd (ZPMC), Changxing Island **Location:** Shanghai, China**CWI Name:** An Qing Xiang**CWI Present:** Yes No**Inspected CWI report:** Yes No N/A**Rod Oven in Use:** Yes No N/A**Electrode to specification:** Yes No N/A**Weld Procedures Followed:** Yes No N/A**Qualified Welders:** Yes No N/A**Verified Joint Fit-up:** Yes No N/A**Approved Drawings:** Yes No N/A**Approved WPS:** Yes No N/A**Delayed / Cancelled:** Yes No N/A**Bridge No:** 34-0006**Component:** OBG**Summary of Items Observed:**

WELDING INSPECTION REPORT

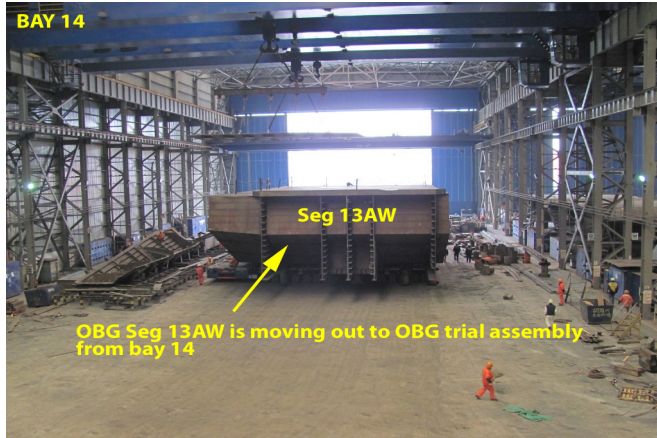
This QA Inspector observed that the segment 13AW has been moved out to the Orthotropic Bridge Girder (OBG) trial assembly from bay 14 for alignment with segment 12CW. See attached photographs for additional details.
